Manhole Inspection Summary

Manhole # S35II_026MH

Insp Date: **3/13/07 10:37 AM**

Location Address: **1706 GUILFORD AVE**

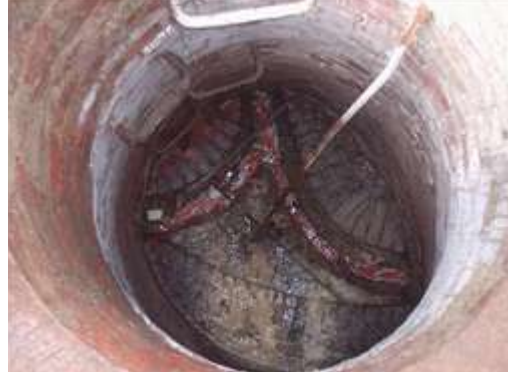
Top View

Corroded steps. Evidence of surcharge - Bench debris. Channel debris.

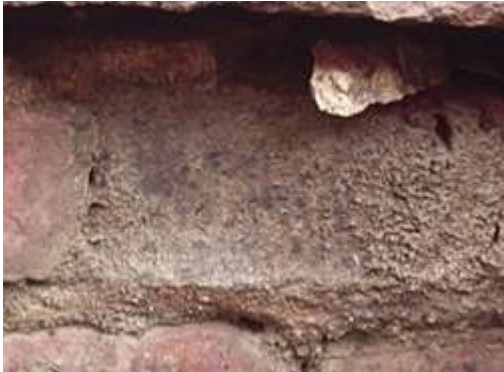
Defect

Condition: ☐ Sound ☐ Cracked ☐ Root Intrusion ☐ Loose Brick ☒ **Deteriorated**

Infiltration: ☐ None ☒ **Joint** ☐ Cracks ☒ **Mortar** ☐ Roots ☐ Wall

Adjustment deterioration and infiltration.

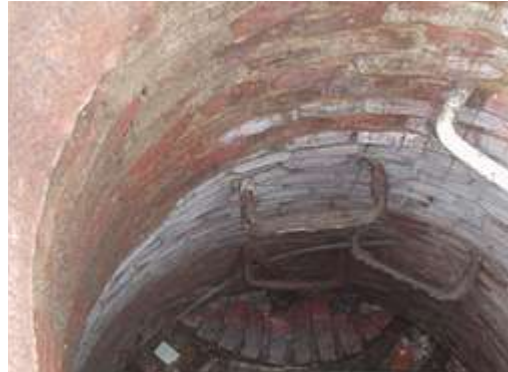
Defect

Infiltration: ☐ None ☐ Joint ☐ Cracks ☒ **Mortar** ☐ Roots ☒ **Wall**

Adjustment and Barrel infiltration.

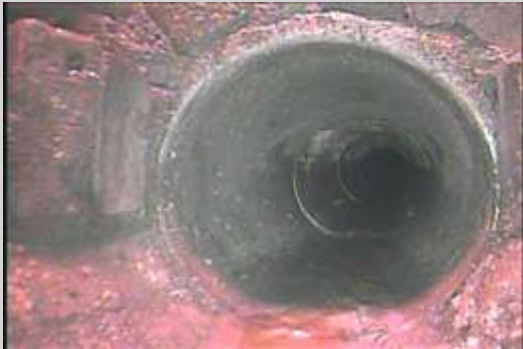
8 in. Circular Gravity Sewer Pipe Out @ 12 O'Clock

Invert Depth: **9.04** (ft.) Flow Characteristics: **Slow**

Deposits: ☒ None ☐ Mud ☐ Sludge ☐ **Debris** ☐ Grease

Infiltration: **None** Pipe Seal Cond: **Unknown**

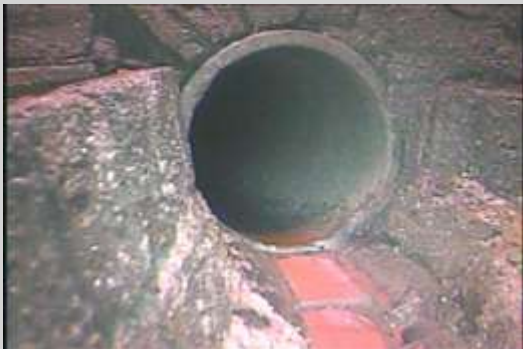
8 in. Circular Gravity Sewer Pipe In @ 4 O'Clock

Invert Depth: **8.45** (ft.) Flow Characteristics: **None**

Infiltration: **None** Pipe Seal Cond: **Broken**

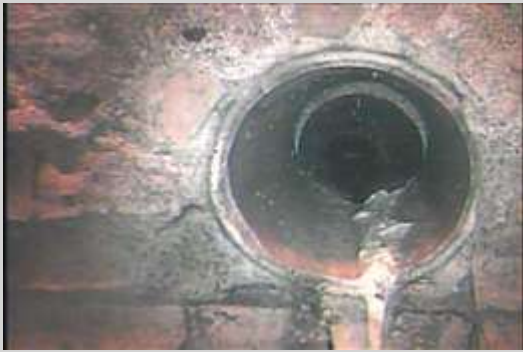
Pipe In @ 6 O'Clock

Deposits: ☐ None ☐ Mud ☐ Sludge ☒ **Debris** ☐ Grease

Silt Depth: **0** (in.) Deposits Extent: **Light**

Infiltration: **Evidence**

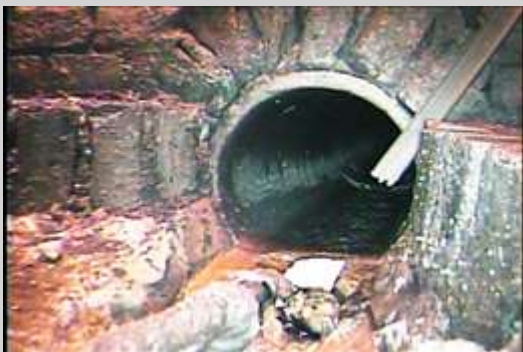
Pipe In @ 9 O'Clock

Barrel deterioration and infiltration. Channel deterioration.

Deposits: ☐ None ☐ Mud ☐ Sludge ☒ **Debris** ☒ **Grease**
